ASBESTOS & LEAD PAINT SURVEY

Santa Ana College
Old Maintenance Compound
1530 W. 17th Street
Santa Ana, California

TRG Project #8126

ASBESTOS & LEAD PAINT SURVEY REPORT

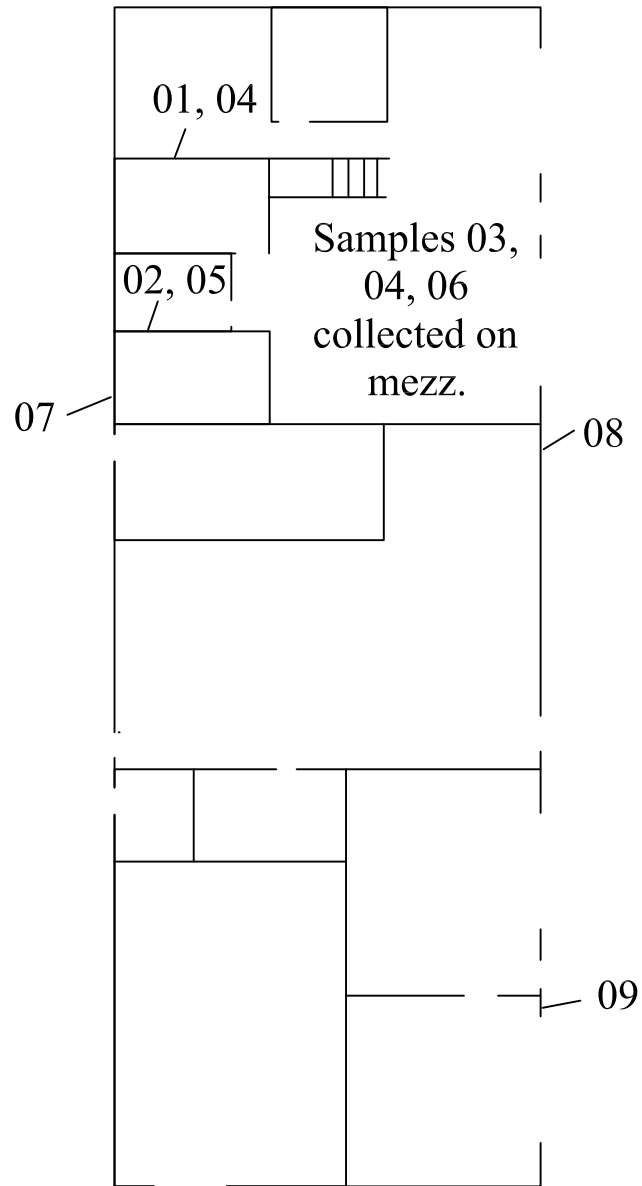
BUILDING J-B FLOOR PLAN WITH BULK SAMPLE LOCATIONS	
Figure #	Figure 3
Revise Date	August 2015
Not to Scale	Scale

A total of 9 samples were collected from interior and exterior suspect ACBM at Building J-B. The results of the asbestos analyses are presented in **Table 1B** attached to this report. Sample locations are shown on the attached **Figure 3**.

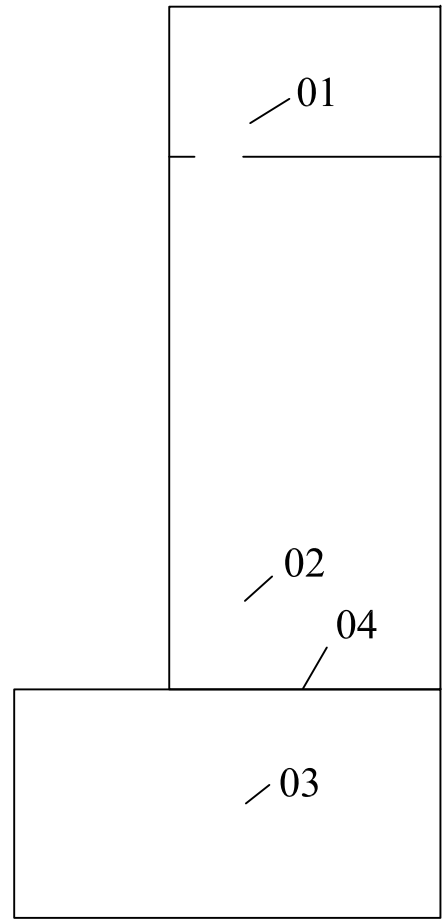
Figure Details
BUILDING J-C ROOF PLAN WITH BULK SAMPLE LOCATIONS
Figure # Figure 4
Revise Date August 2015
Scale Not to Scale

Flashing cement on all three roofs should be removed as non-friable asbestos containing material based upon sample results from Buildings J-A and J-C

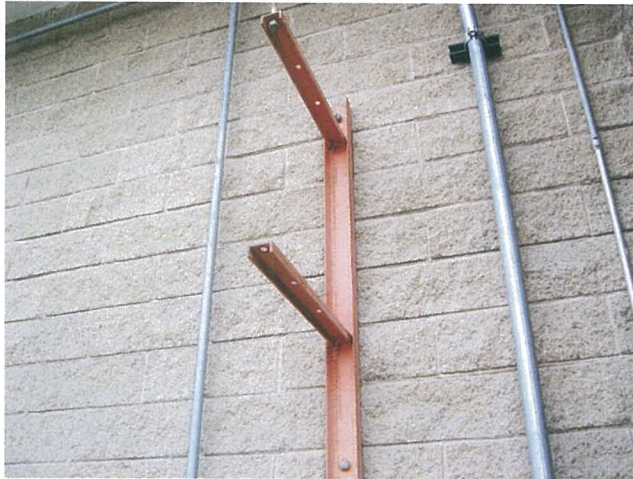
PHOTO # 1
Support

The paint on the exterior and interior of the buildings is in fair to poor condition. Most tack boards and chalk board tested positive for lead. Ceramic tile wall inside of J1 area 4 tested positive for the presence of lead. Exterior supports in poor condition and are in need of paint stabilization.
